## Defect Listing

| Pipe Segment Refere...<br><b>E-16_E-15</b> | City<br><b>Oliver Springs</b> | Street<br><b>Sleepy Hollow</b> | Material<br><b>PolyVinyl Chloride</b> | | Location C...<br><b>Yard</b> | Sewer Use<br><b>Sanitary</b> |

| SPRI<br><b>5</b> | MPRI<br><b>N/A</b> | Work Order<br><b>4397-02</b> | | Purpose<br><b>Pre-Rehabilitation Survey</b> | | |

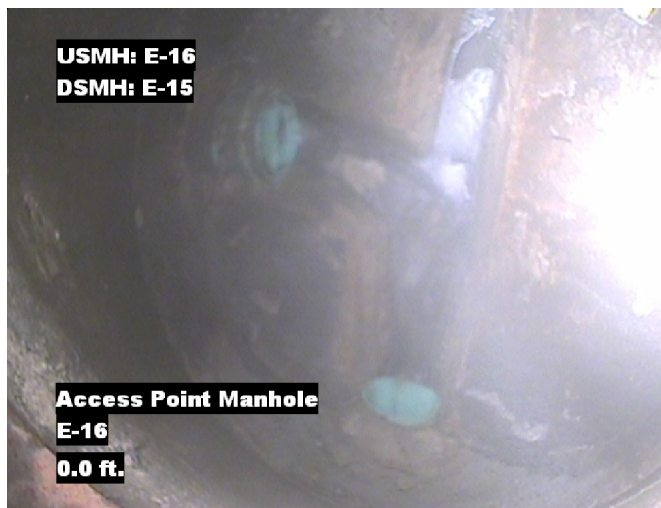
Distance: 0.0 ft. Grade: 0  
Condition: Access Point Manhole  
Remarks: E-16

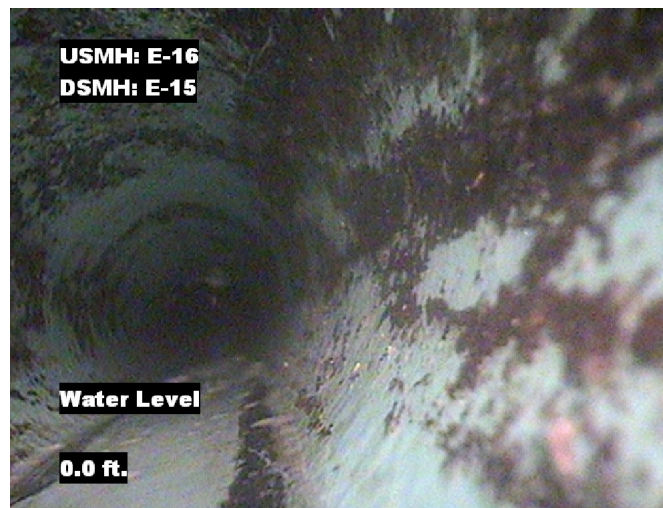
| Distance | Condition | Cont. Dfct. | Values | | | Joint | Clock Position | | Grade |
|---|---|---|---|---|---|---|---|---|---|
| 0.0 ft. | Water Level | | | | 5 | <input type="checkbox"/> | | | |

Distance: 0.0 ft. Grade: 0  
Condition: Water Level  
Remarks: N/A

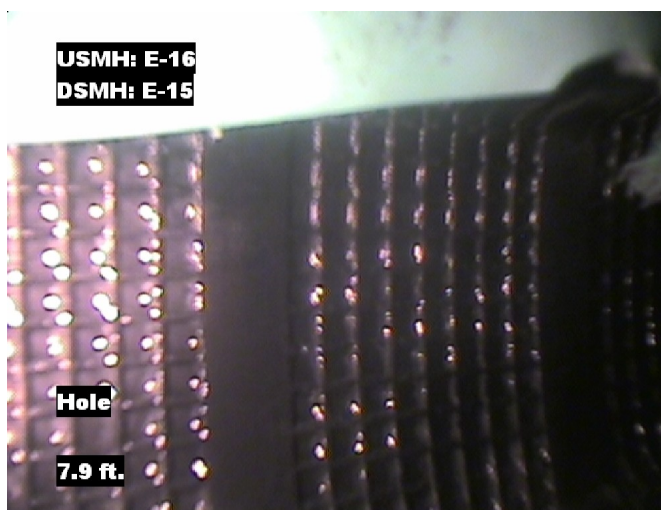
| Distance | Condition | Cont. Dfct. | Values | | | Joint | Clock Position | | Grade |
|---|---|---|---|---|---|---|---|---|---|
| 7.9 ft. | Hole | | 6 | 2 | 0 | <input type="checkbox"/> | 12 | 12 | 5 |

Distance: 7.9 ft. Grade: 5  
Condition: Hole  
Remarks: N/A

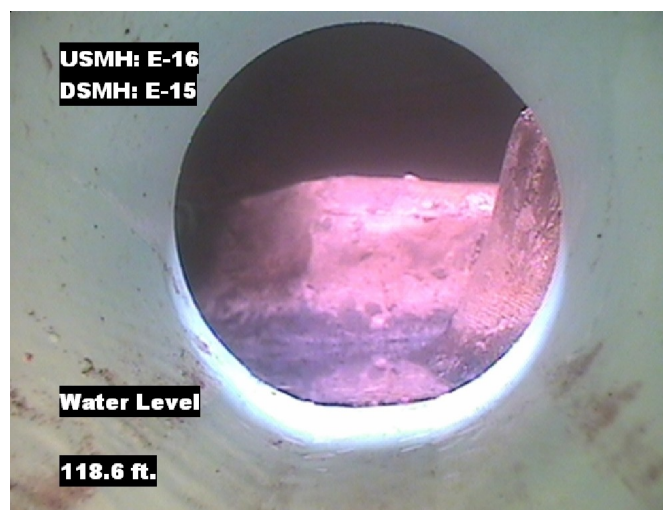
| Distance | Condition | Cont. Dfct. | Values | | | Joint | Clock Position | | Grade |
|---|---|---|---|---|---|---|---|---|---|
| 118.6 ft. | Water Level | | | | 5 | <input type="checkbox"/> | | | |

Distance: 118.6 ft. Grade: 0  
Condition: Water Level  
Remarks: N/A

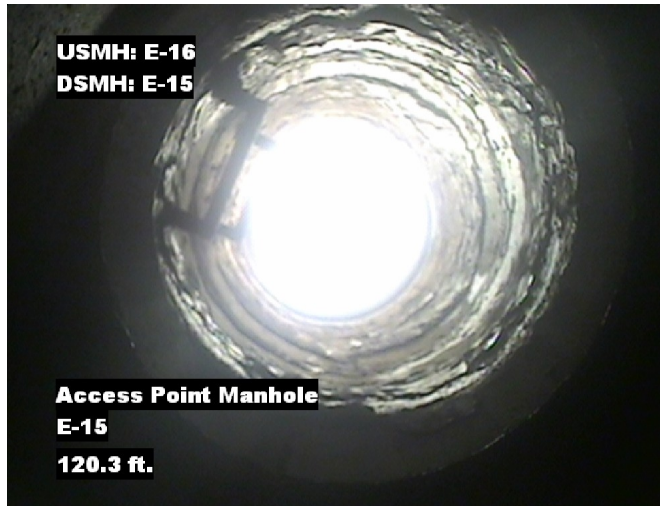
Distance: 120.3 ft. Grade: 0  
Condition: Access Point Manhole  
Remarks: E-15
